MAN-MADE FLOOD DISASTER IN THE SAVANNA TOWN OF GOMBE / NE NIGERIA
 THE NATURAL HAZARD OF GULLY EROSION CAUSED BY
 URBANIZATION DYNAMICS AND THEIR PERI-URBAN FOOTPRINTS

HEIKO BALZEREK, WERNER FRICKE, JÜRGEN HEINRICH, KLAUS-MARTIN MOLDENHAUER
 and MARKUS ROSENBERGER

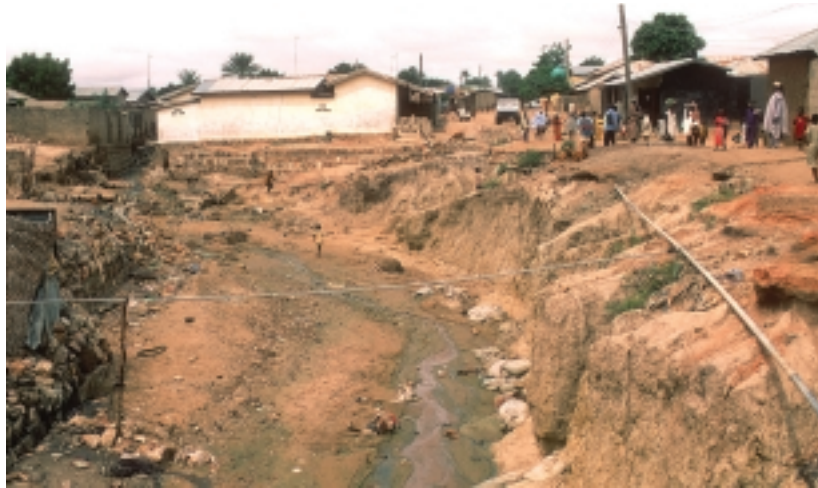
Photo 1: The old town of Gombe: isolation of wards by gully erosion and destruction of infrastructure
Source: BALZEREK 2000

were already seriously threatened by gullies (GROVE 1951, 1952). In spite of this serious threat, official awareness and public enlightenment concerning the process, together with socio-economic limitations, result in habitual construction of settlements in the same endangered places (Photo 1).

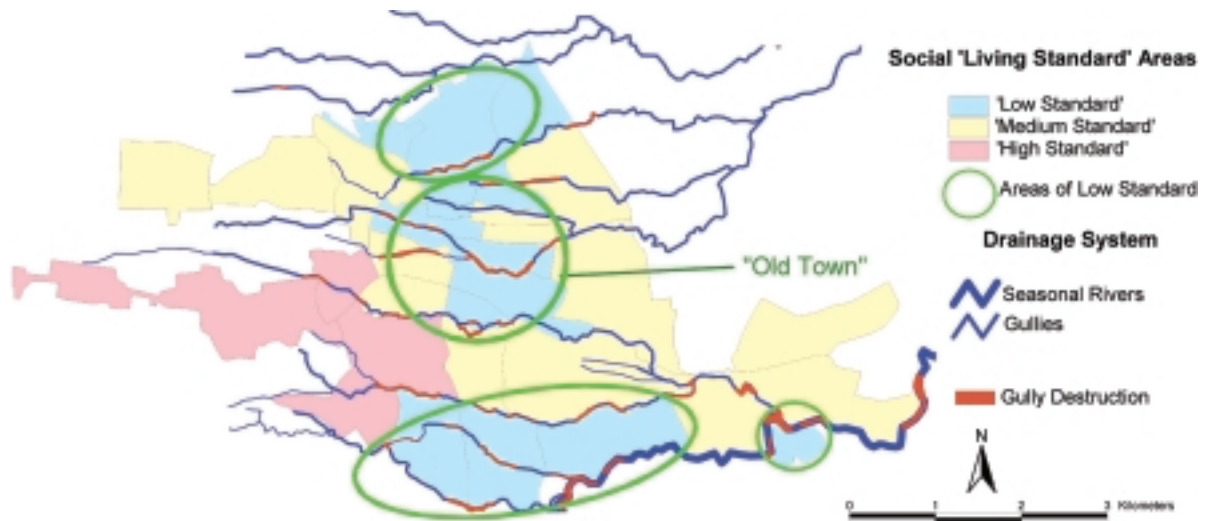
Fig. 4: The dominant social structure and sites of gully erosion in Gombe. Source: Own survey; BALZEREK 2003

With the help of a sample survey of 1,056 households⁴⁾ focussing on the socio-economic household conditions in all parts of Gombe, the wards can be distinguished in three classes of a statistically generated 'Living Standard Index': 'Low', 'Medium' and 'High Living Standard', symbolising the access to modern facilities and hygiene within the family compound. Figure 4 indicates four areas, where 'Low Living Standard' can be monitored.

Focusing on the drainage system of Gombe the destruction of urban building structures by gully erosion is symbolised by red segments along the gullies. Figure 5 identifies that most extraordinary damages affect the inhabitants of the 'Low Living Standard' areas. Many households of those areas belong to the very vulnerable groups, who are not in the position to overcome the results of the hazards but are caught in the vicious circle of poverty.

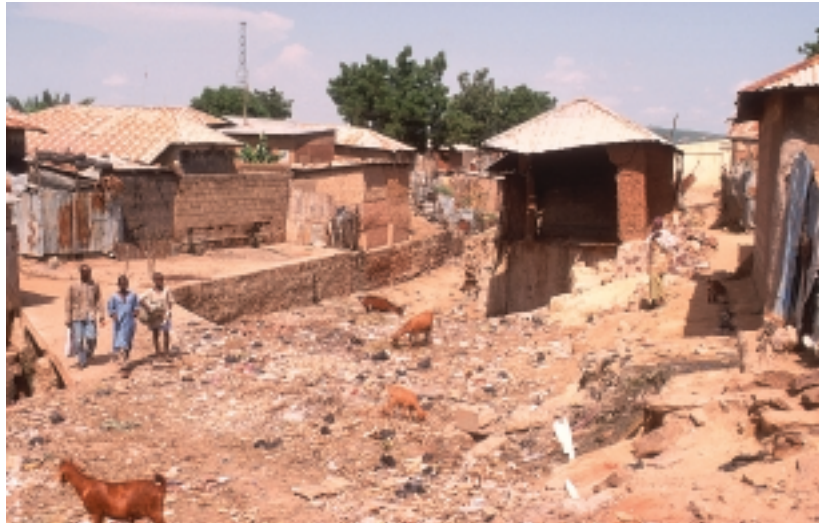
Photo 2: A flash flood damaged this house in the old town adjacent to a sewage gully (Photo: BALZEREK 2000)

tion or influence or power of these households, and their inadequate financial basis (Photos 2 and 3). HORLICK-JONES et al. (1995, 122) describe four factors shaping the vulnerability of the population:

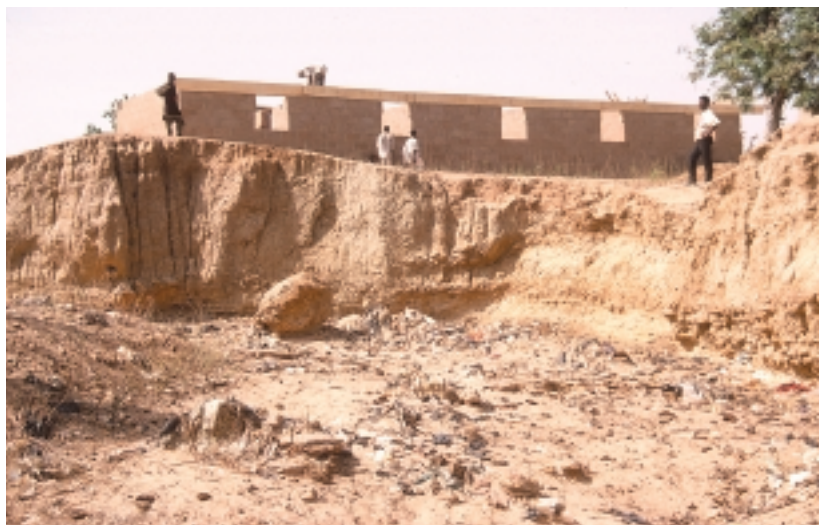
Photo 3: Close to an undercutting slope of a seasonal river a new building is under construction
